STABILIZATION OF MOVING LAND MASSES BY CAST-IN-PLACE PILES

John B. Palmerton

U. S. Army Engineer Waterways Experiment Station
P. O. Box 631, Vicksburg, Miss. 39180

Final Report

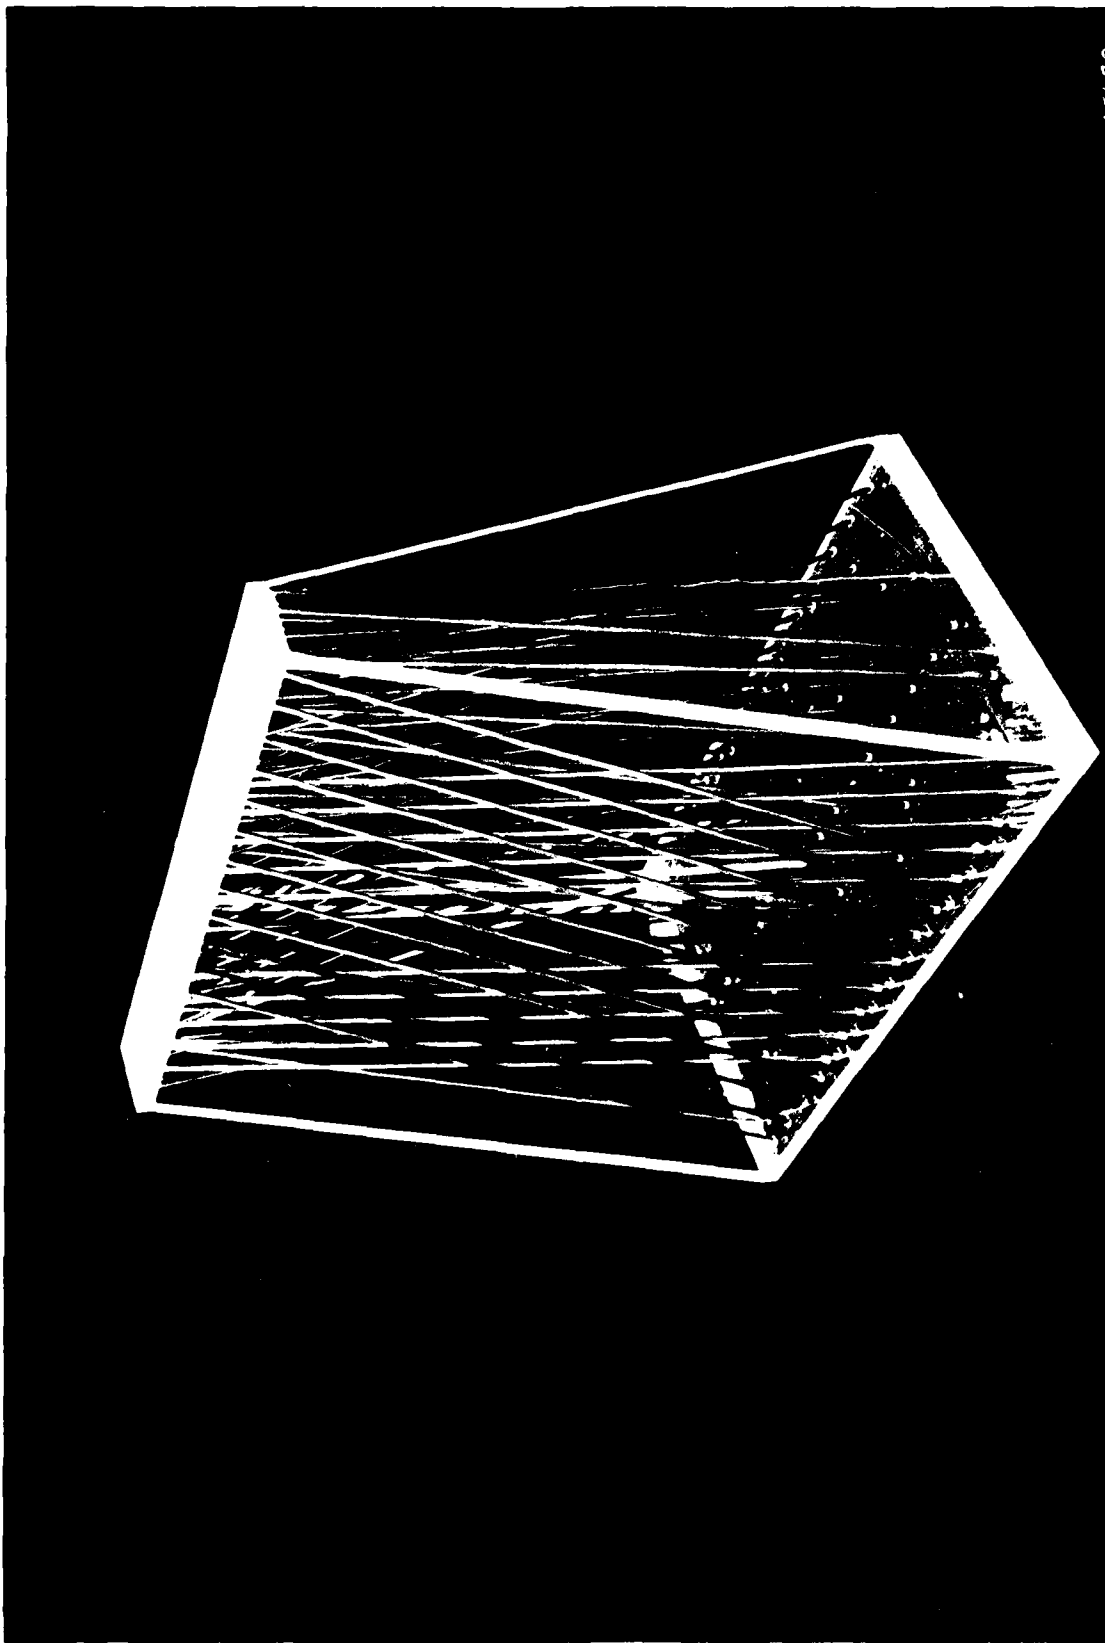
53. Figure 2 is a photograph of a built-to-scale plastic model. It is evident from the photographs that the piles are tightly interlaced. Near the vicinity of the pile cap, the piles almost touch one another. The pile density is 2-1/2 piles per ft of retaining structure. During the actual construction, it was not uncommon for a new boring to intersect and go through a previously placed pile. This would not necessarily be evident during typical construction. However, when pile 376 was bored, the bit struck instrumented piles 372 and 371. This was made evident due to pieces of strain gage electrical cables being blown out of the new borehole. The electrical cables were attached to the reinforcing bars of piles 372 and 371.

Figure 2. Model of pile systems, California site

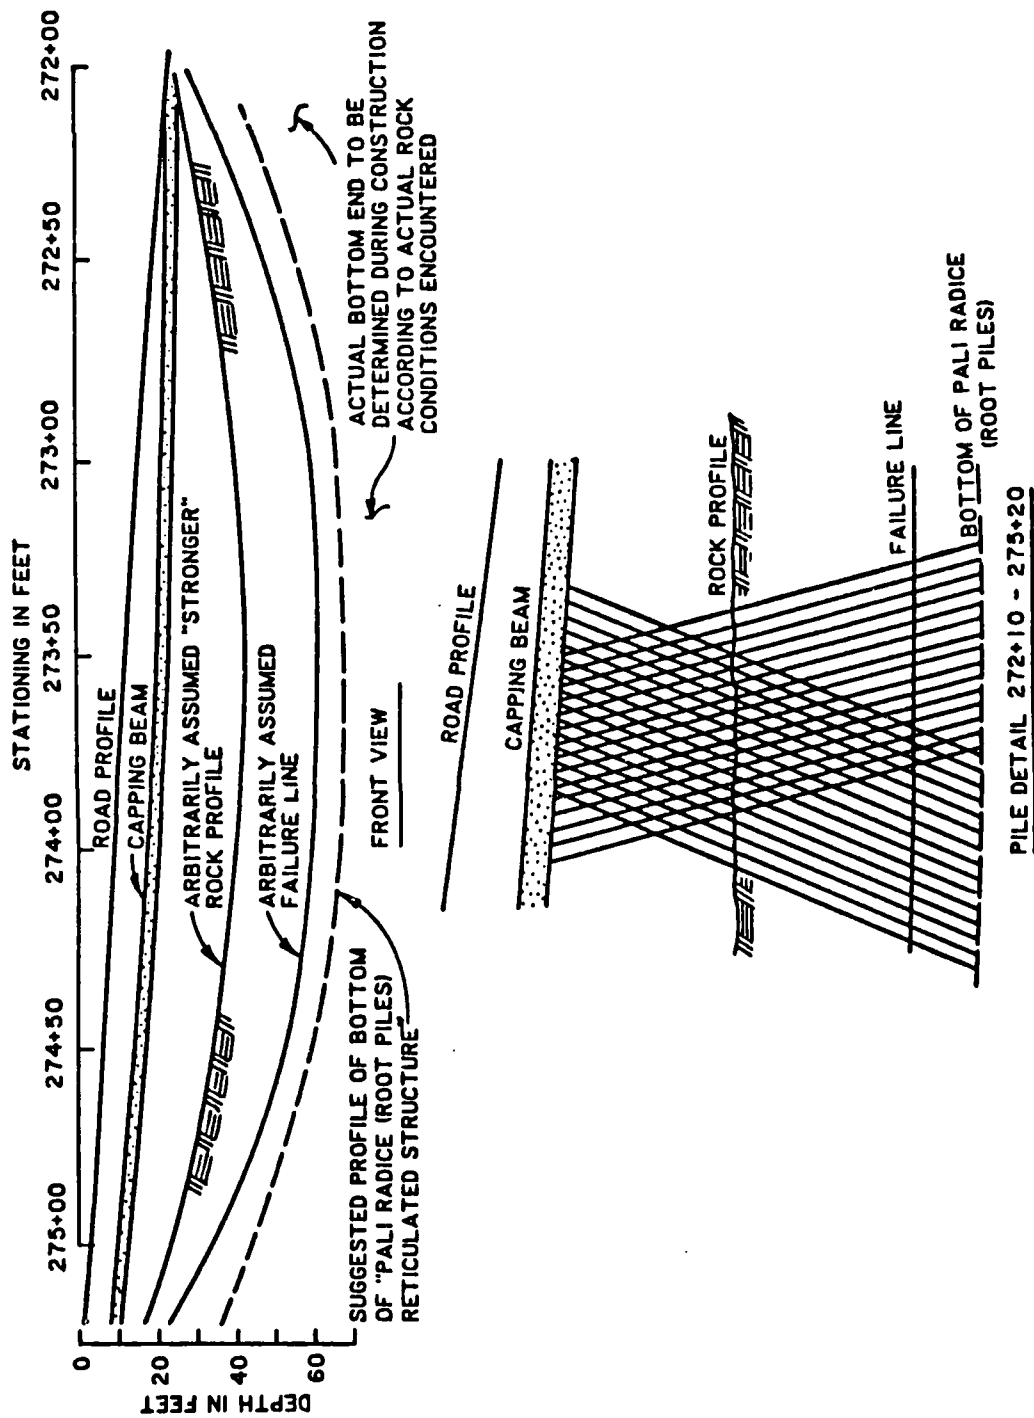
49. Figures 19-21 are construction drawings showing pertinent details. Figure 19 shows the front view of the wall, Figure 20 is a plan view indicating the numbering system, and Figure 21 is a cross-sectional view of the structure.

Figure 19. Front view of pile network

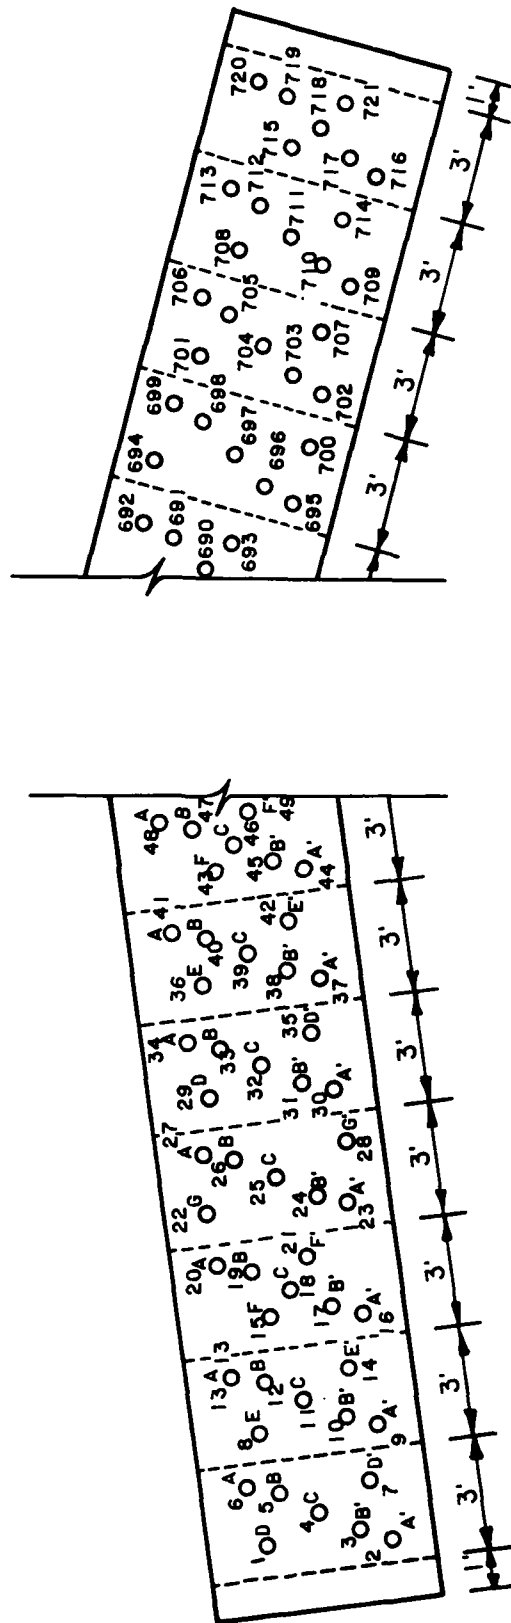
Figure 20. Plan view of pile network

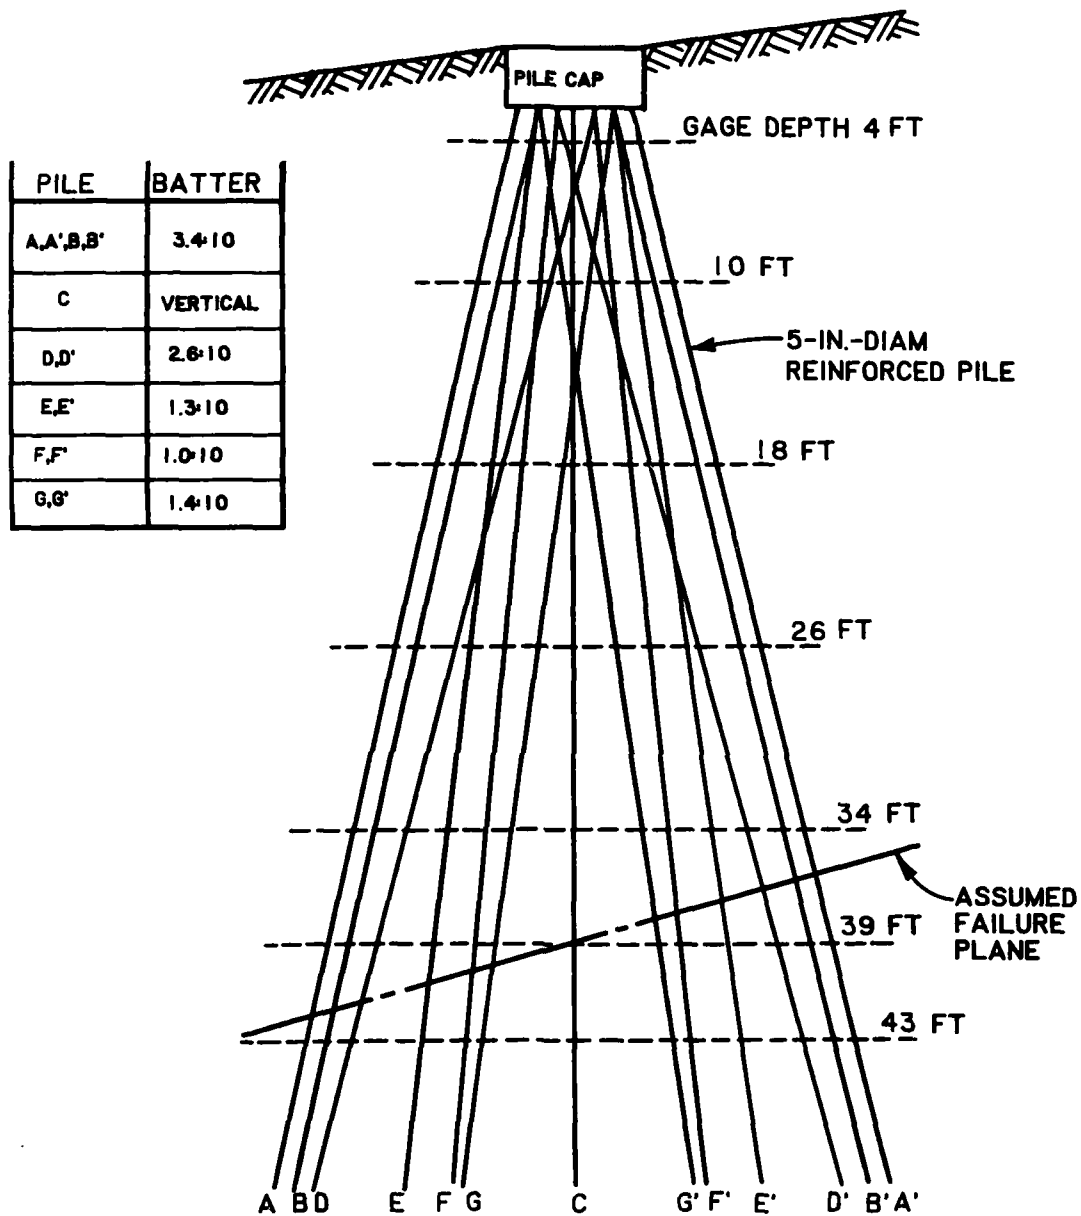
56. A cross-sectional view of the instrumented section is shown in Figure 21. The planned elevations of the gaging stations are shown on this figure. Each instrumented pile had a total of 28 full-bridge foil strain gages. These gages were placed in groups of four (located at 90-deg intervals around the reinforcing bar) at seven depths along the bar. The depths below the top of the pile cap at which the gages were placed were 4, 10, 18, 26, 34, 39, and 43 ft. The instrumented sections were located at approximately station 273 + 60.

Figure 21. Cross-sectional view of pile network

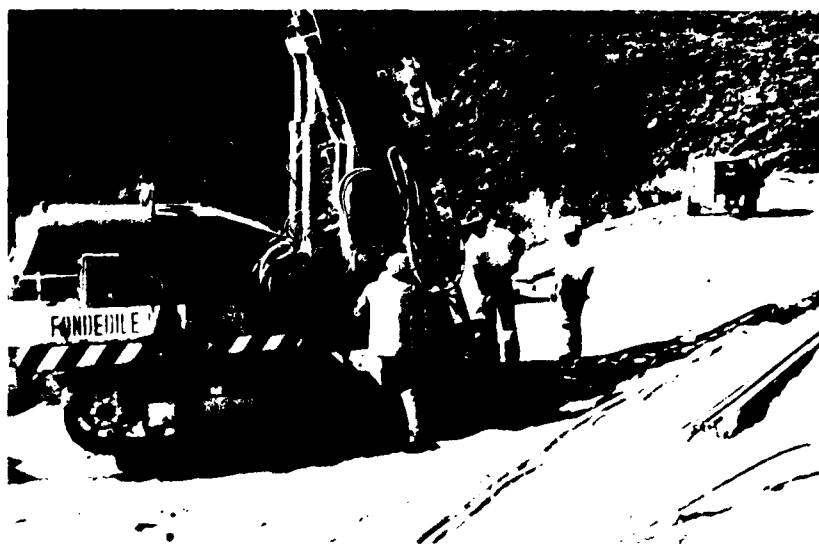
51. Following the construction of the capping beam, drilling commenced. The uncased borings were 5 in. in diameter and were drilled to depths ranging from 50 to 80 ft. The drill rigs were manufactured by Fondedile, S.A., Naples, Italy (see Figure 23). The borings were sequenced in a more or less random fashion, the criteria being not to drill a new borehole in the vicinity (e.g., 30 ft) of a freshly poured pile. After a boring was completed, a No. 9 (1-1/8-in.-diam) reinforcing bar (grade 60) was placed in the hole. The reinforcing rods were in 20-ft lengths. These lengths were overlapped and welded together as they were lowered into the borehole. A tremie pipe (2-in.-diam.) was then inserted into the borehole (alongside the reinforcing steel) and the grout was pumped into the hole. No attempt was made to insure that the bars were centered in the concrete. Indeed, due to the batter angle and the insertion of the tremie pipe, it would be impossible for the bars to be centered within the borehole.

Figure 23. Drilling rig at construction site

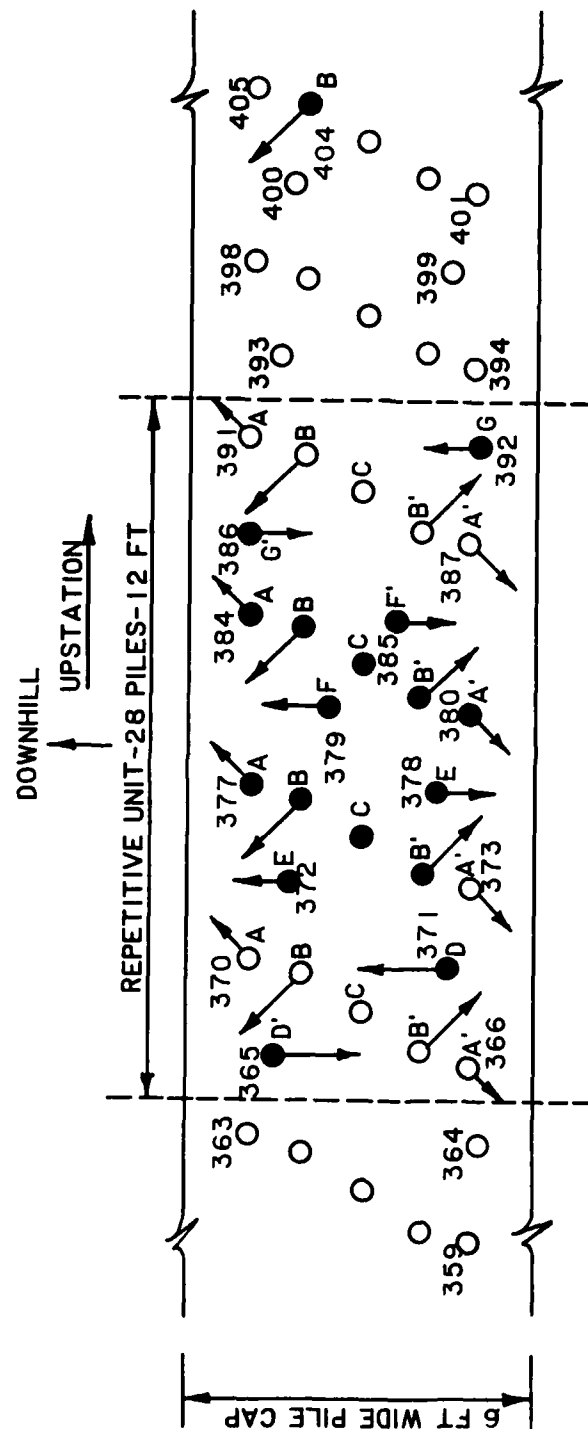
54. Figure 24 shows a plan view of the pile layout. This view shows the repetitive nature of the system. The repetition number is 28; that is, the value 28 (or a multiple of 28) must be added to any given pile location number to obtain the location of a pile that is similar (with respect to its neighboring piles) to the given pile. Included in the 28-pile unit:

55. At the onset of the project, it was planned to instrument 18 piles within a repetitive unit. With one exception, this plan was accomplished. The exception was pile 373, a Type A' pile. Because of construction difficulties, it was not possible to install this instrumented pile. The instrumented bars originally planned for pile 373 were later placed in pile 404, a Type B pile. The instrumented piles are indicated by the darkened circles shown in Figure 24. The following pile types were instrumented:

Figure 24. Plan view of instrumented section

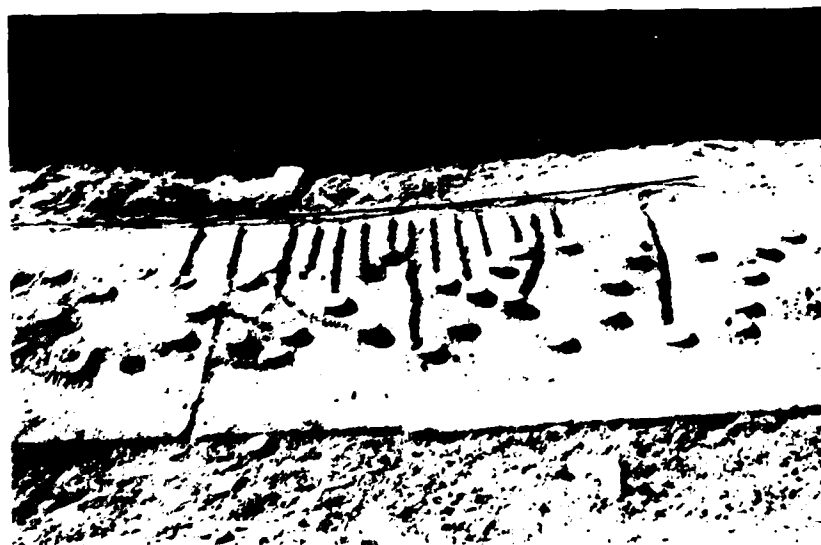
60. The ends of the instrumented reinforcing bars were stamped and color-coded so that the orientation of the bar could be visually maintained during insertion and welding. During insertion, the cables extending from the instrumented bars were taped to the bar at 10-ft intervals. Channels emanating from the borehole were provided (Figure 26) within the capping beam. Following the placement of the bars, the borehole was grouted and the channel containing the cables was filled with grout. The instrumented boreholes were grouted from the surface because the tremie would not pass the cables and strain gages without damage to the cables and gages.

Figure 26. Channels for placement of electrical cables

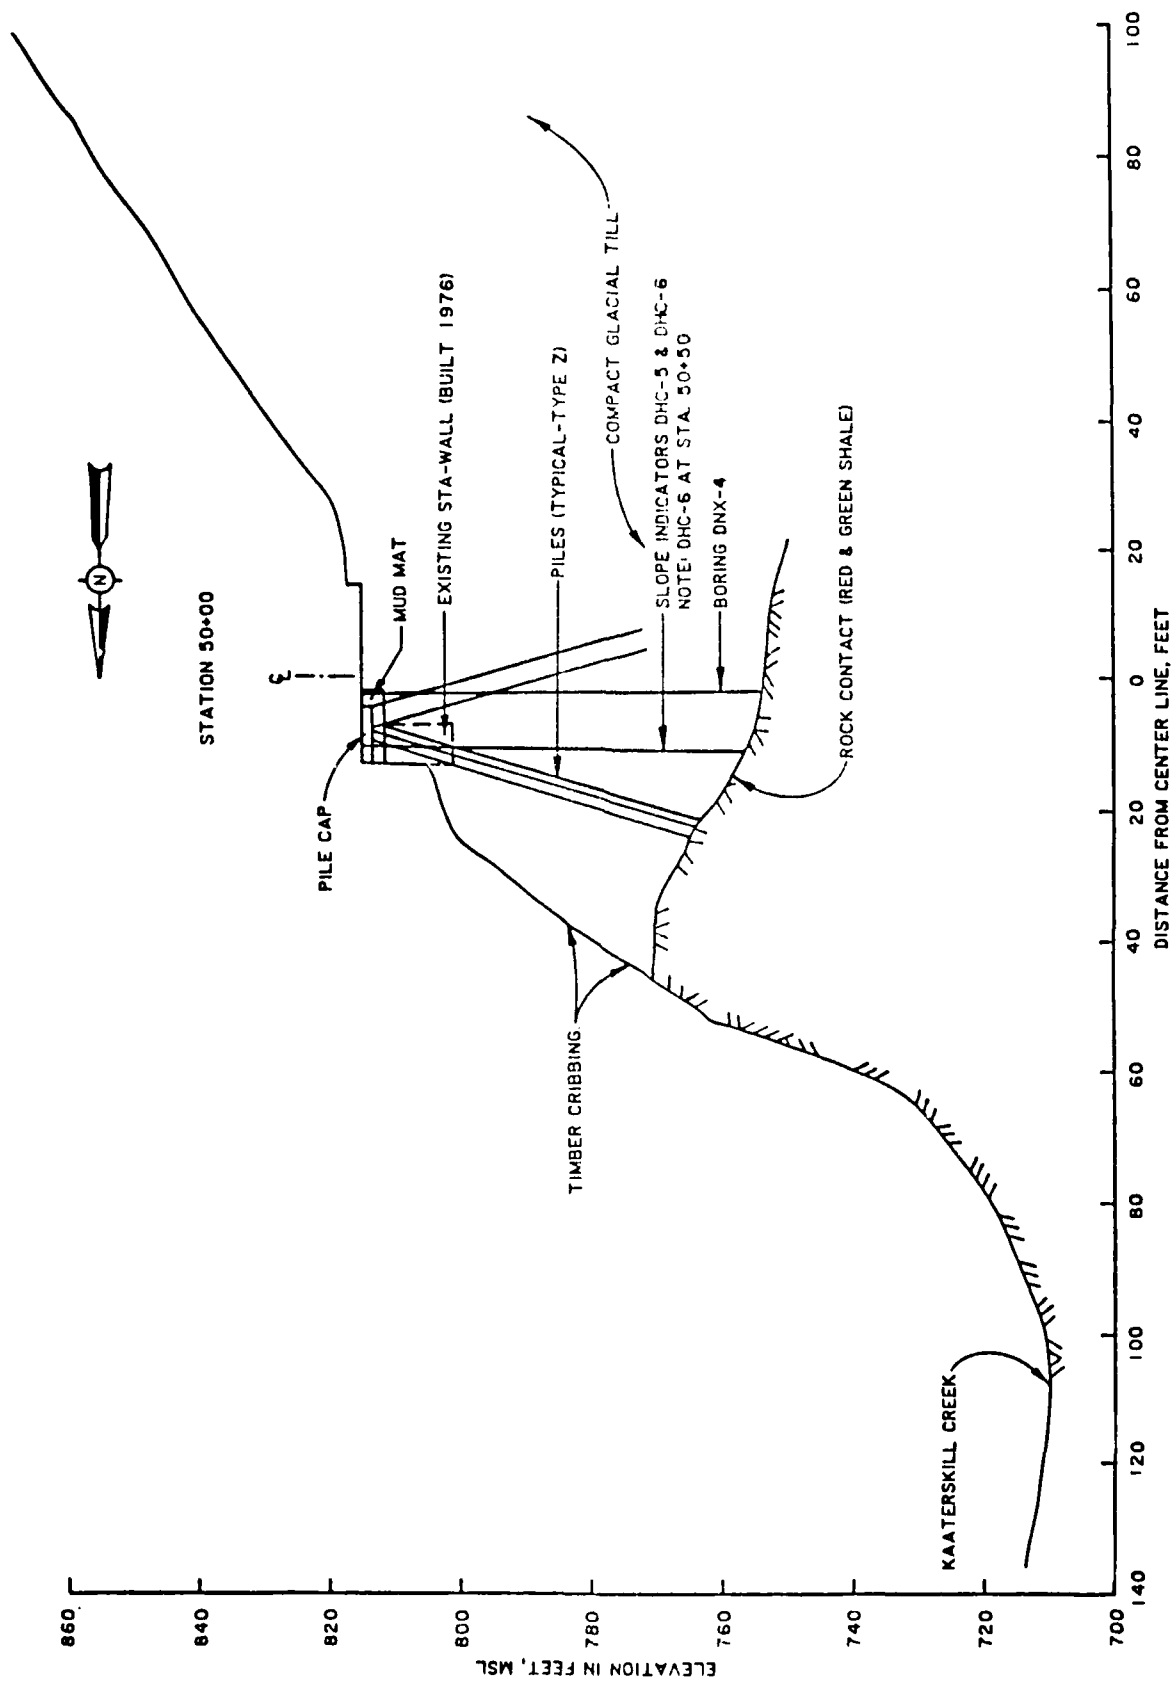
Figure 71. Profile at sta 50+00

roadway surface) where bedrock consisting of a green and red shale was encountered. No evidence of slippage planes was noted on the driller's logs nor were soil samples obtained. The profile of the roadway down to the creek is shown in Figure 71. This figure also indicates the location of the new pile construction and other pertinent details.

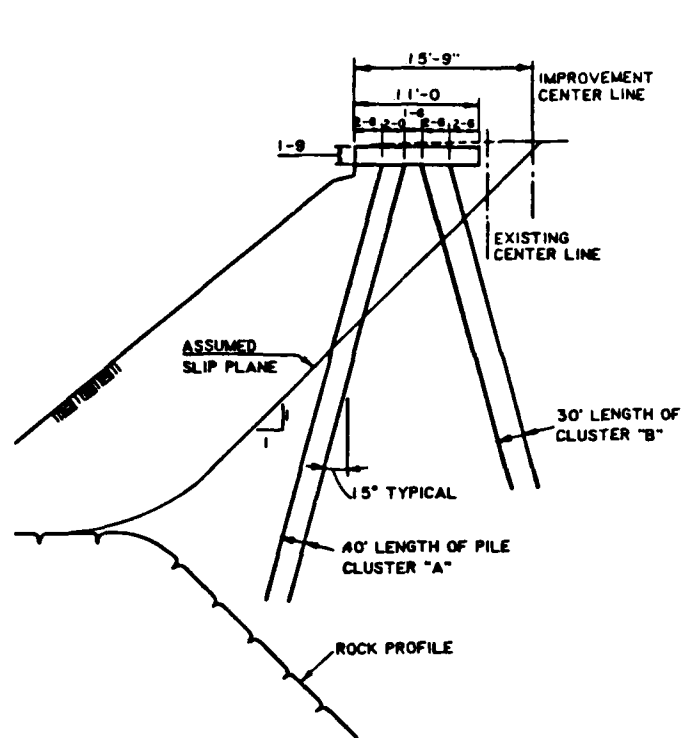
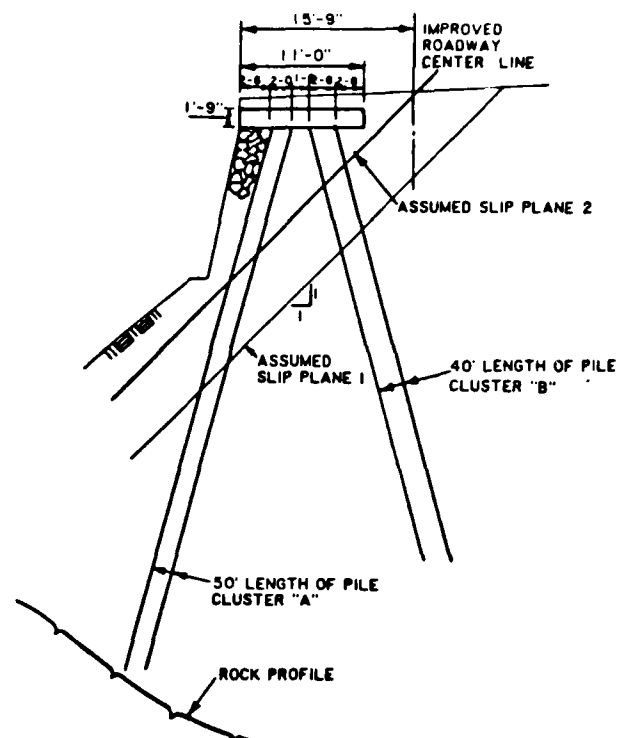
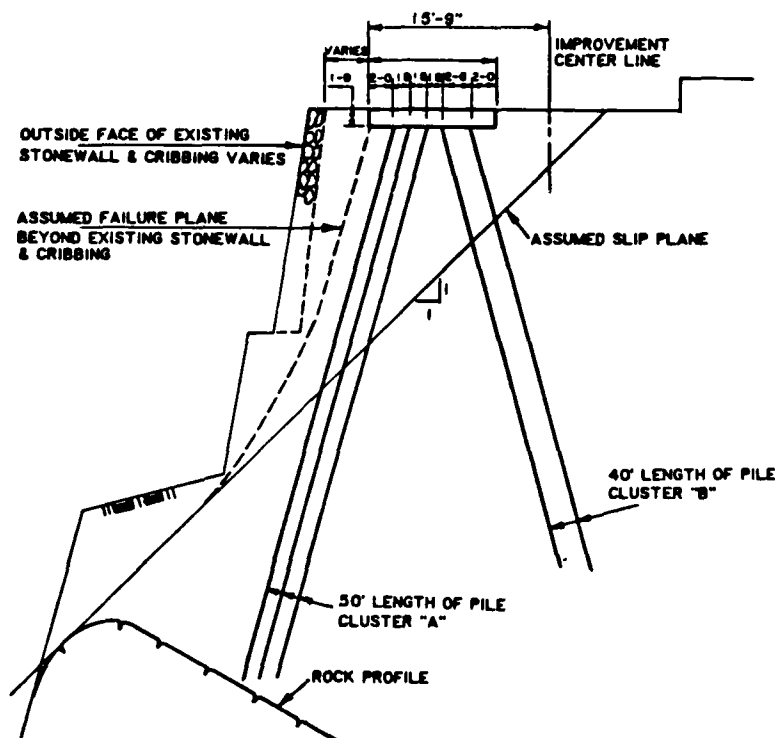
Figure 72. Pile types X, Y, and Z

79. Five conditions were assumed during the design process. The considerations pertinent to three of the designs are shown in Figure 72. The design for types X and Y yield a four-pile arrangement (two piles battered upslope and two piles battered downslope). The type Z arrangement yielded a five-pile arrangement, the additional pile battered downslope. (The other two design conditions were for a culvert crossing and for a condition similar to type Z, but containing a wider pile cap.) Type X is characterized by a single shear plane, type Y by a double shear plane.

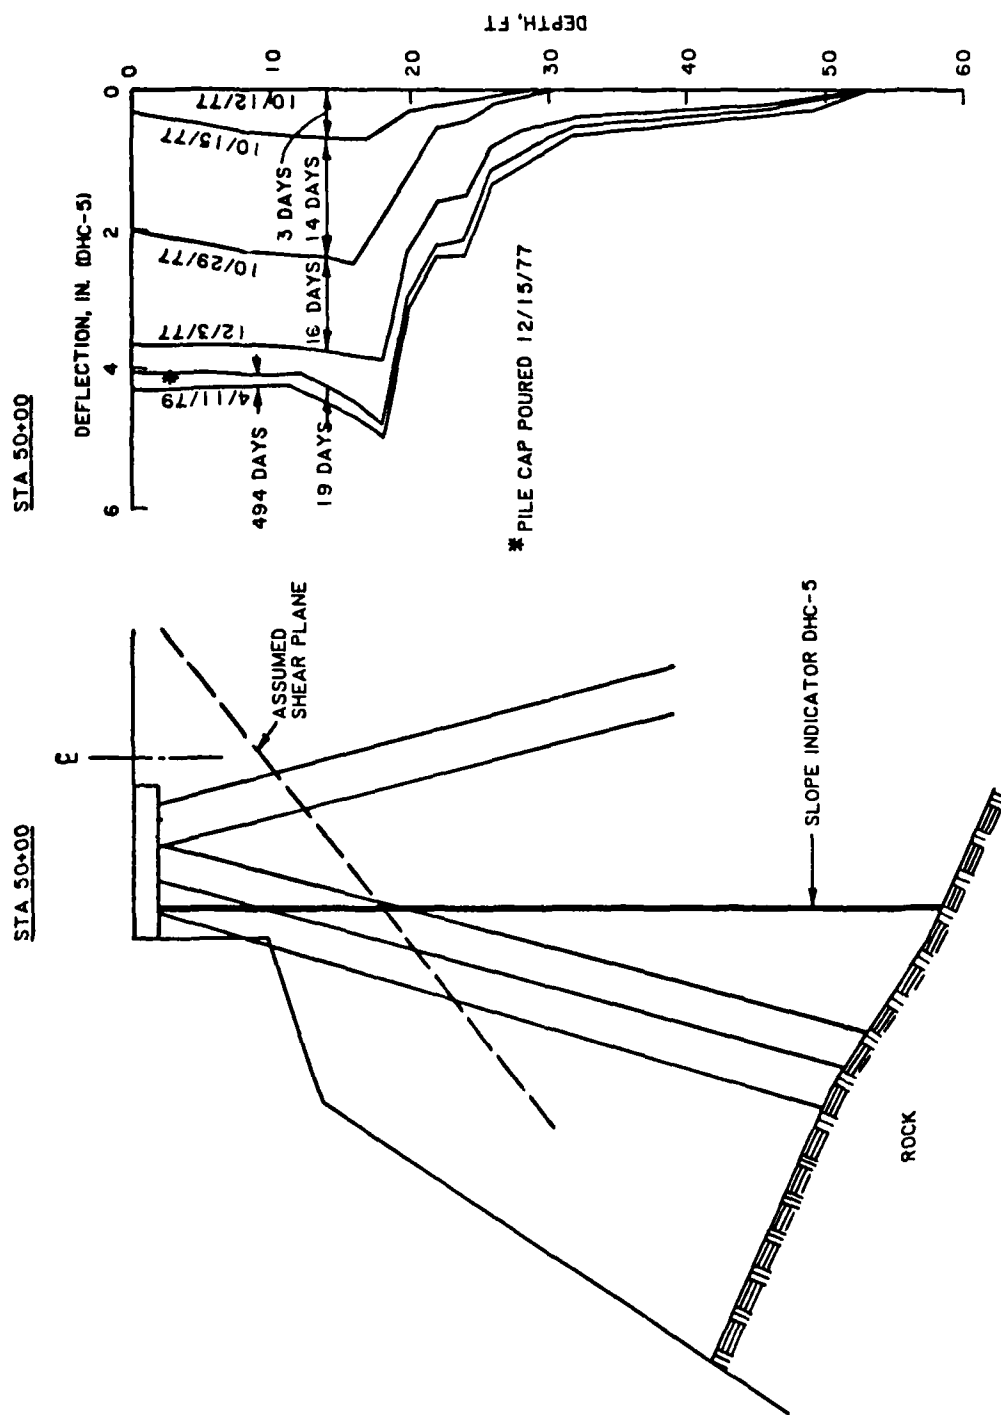
2. STATION 50+00, DHC-5

96. The slope indicator data presented in Figure 97a shows the development of a shear surface between depths of 18 and 24 ft at station 50+00. The maximum deflection recorded was 5.0 in. at the 18-ft depth. The slope indicator at station 50+50 (DHC-6) recorded a maximum deflection of 2.2 in. at the surface as shown in Figure 97b; however, a clearly defined shear surface is not as apparent as at station 50+00.

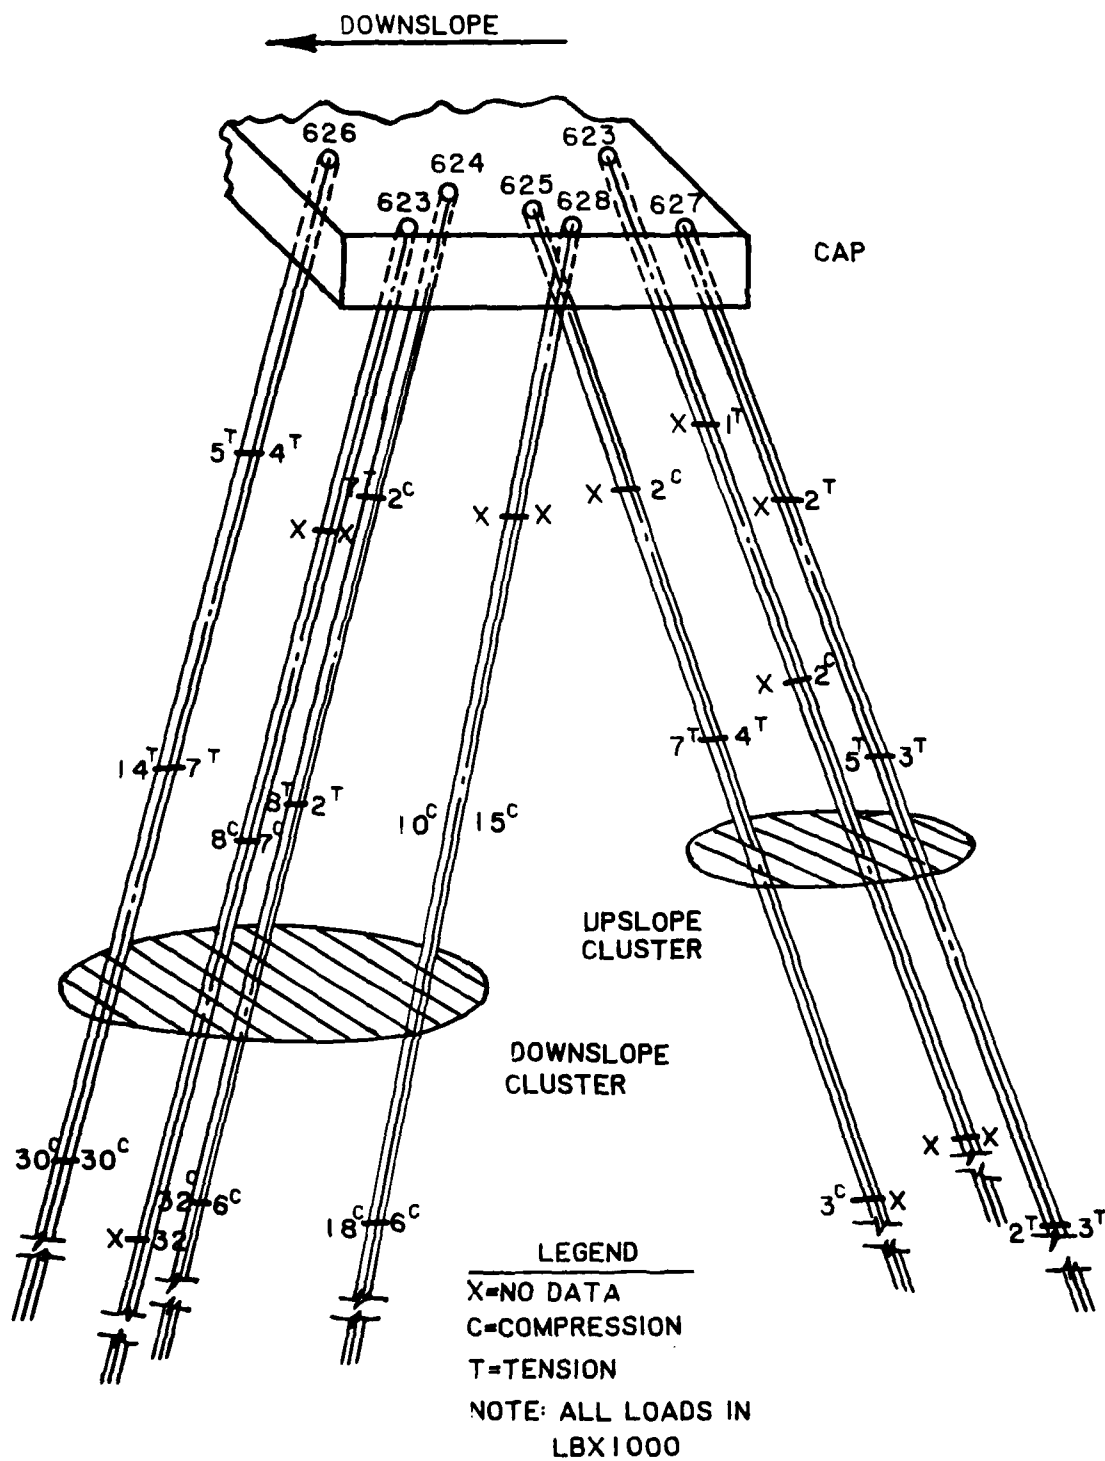
Figure 99. Strain gage loads

101. The postconstruction loads acting at the strain gage locations are schematically shown in Figure 99. For clarity, piles 623 and 627 are shown beside piles 626 and 622; however, in profile they are coincident. The axial load in each rebar at the gage station is (theoretically) the average of the individual readings at the gage station. The average axial load at each gage station (postconstruction) is shown in Figure 100. Ideally, the figure represents the loads within the "composite beams" formed by the upslope and downslope pile clusters. The design shear plane is also shown in Figure 100. The slope indicator data given in Figure 97b verify that the location of the design slide plane was essentially correct at least as to the depth of the maximum deflection. The slope indicator data do not indicate a single abrupt shear plane, but a rather wide shear zone extending from depths of 18-28 ft.

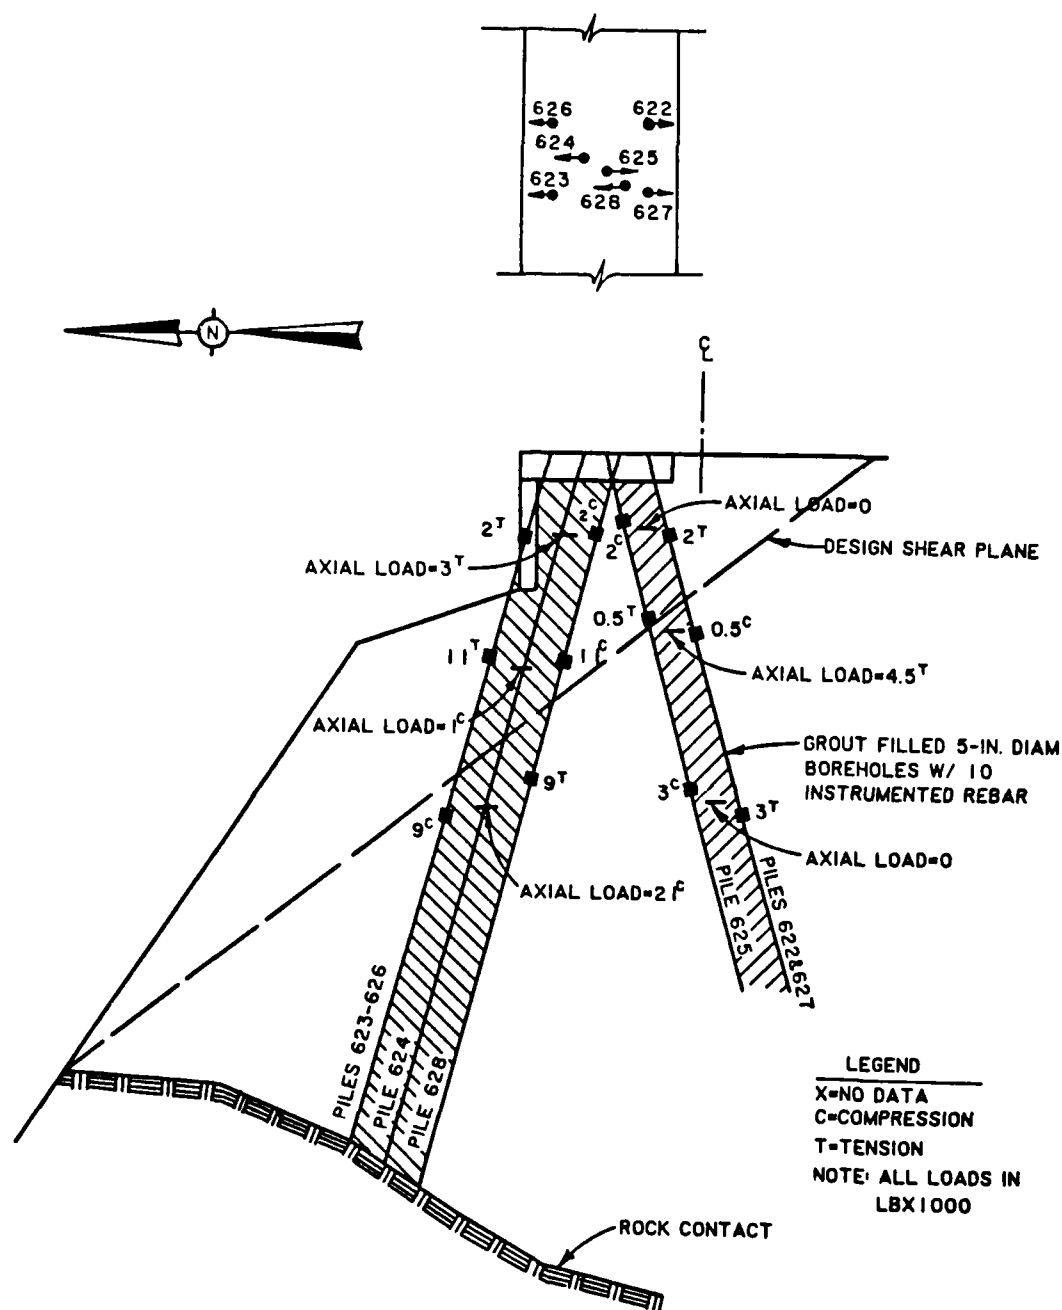
Figure 101. Interpreted bending and axial loads in "beams"

102. The loads within the composite beam due to pure bending may be calculated by deducting the average axial load from the outer fiber (outer rebar) loads. Figure 101 shows the interpreted bending loads and axial loads acting on the upslope and downslope "composite beams." There are an insufficient number of data points to accurately define the "beam" behavior; however, the load interpretation represented in Figure 101 is entirely reasonable when compared to the slope indicator data. Qualitatively, the interpreted bending loads would yield a pair of beams bent in the shape shown in Figure 102. This schematic interpretation is consistent with design considerations except for a reversal of the expected bending in the upslope cluster. Apparently, the forces in the downslope cluster (which includes tensile axial loads in the upper portions) are transferred through the pile cap to the upslope cluster causing the upslope "beam" to be pulled into the material between the pile clusters. The upslope "beam" also does not experience appreciable axial loading except for a tensile load in the vicinity of the design shear plane.

103. The axial "beam" loads in the downslope cluster indicate tension within the upper 10-12 ft of the structure and compressive axial loads elsewhere. The design axial load on the downslope cluster (see Figure 73b) of 2020 lb per ft of the structure should produce an axial loading in the "beam" of 10,250 lb (i.e., each 5 ft of structure is supported by one downslope cluster). The interpreted axial load of 21,000 lb is not considered to be inconsistent in light of the absence of axial loading on the upslope cluster and the lack of definition of the shear plane.
